An Assessment of Processes and Strategies for Management of the Penarth Coast

A thesis submitted in partial fulfilment of the requirements of the University of the West of England, Bristol for the degree of Doctor of Philosophy at Bath Spa University College

September 2005

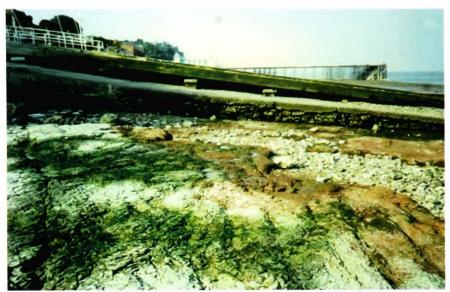
Plate 1.1: Exposed foundations Yacht Club Slipway.

To the north, marl bedrock is clearly visible, together with exposed foundations and underslab construction of the Yacht Club slipway. This qualitative evidence demonstrates loss of beach cover and there is a 300 mm clearance, from the underside of the foundation, to the beach surface. The new lifeboat slipway, seen behind the first slipway, was completed in 1995.

Plate 1.1 characterises loss of beach material along this section.

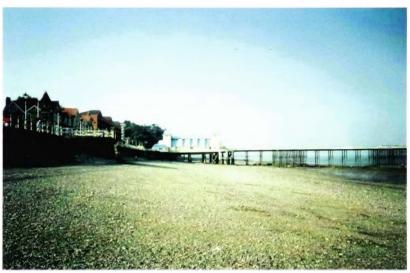
Plate 1.3: Penarth beach – September 1997.

Furthermore, it can be seen that there has been a change in the beach composition. This loss of beach material is critical to sea defence stability and management, especially along the promenade, as the seawall is built on marl bedrock. As the effective depth of the sea increases, the likelihood of flooding and structural damage to the Esplanade also increases. The owner of Chandlers Restaurant, situated on the Esplanade, supplied further anecdotal qualitative evidence of change. At the time of an interview in September 1997, the restaurant had been flooded twice in the previous eighteen months compared with twice in the previous twenty years (Rabaiotti, 1997: pers. comm.). Plate 1.4 shows the southern side of the pier construction where it meets the seawall. The clean area at the junction of the

beach and structures indicates a fall in beach level and that this was a relatively recent occurrence.

A comparison of Plate 1.2 (Bullen 1993a), showing the beach condition in September, 1992 and Plate 1.3 from September, 1997, clearly shows a loss of beach material along this section.

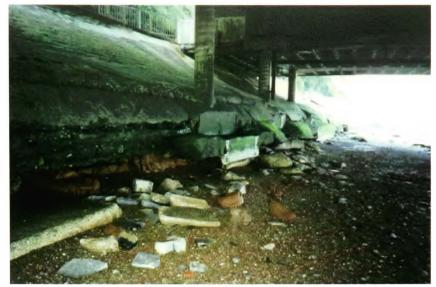
Plate 1.5: Sea defences below multi-storey car park.

The multi-storey car park and seawall north of the pier, as shown in Plates 1.5 and 1.6, were in a poor state of repair and in need of urgent attention. Plate 1.7 of the slipway adjacent to the car park shows similar conditions to those seen in Plate 1.1. In both cases, the beach on the southern side had eroded to such an extent that the foundations were exposed. Further north, a comparison of Plate 1.8 (Bullen 1993a), and Plate 1.9, clearly indicates the undermining and loss of beach material adjacent to an old quay.

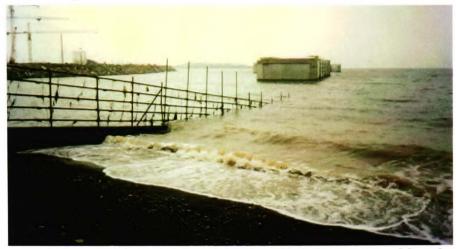
Plate 1.10: Barrage construction adjacent to groyned beach.

Continuing NNW and approaching the site of the Cardiff Bay Barrage there are five groynes. The four nearest the barrage are normal to the cliff face and form three bays, whilst only part of the fifth groyne is at 90°. These last four groynes successfully retained beach material with their southern flanks retaining higher levels. Clear of the groyne field, mud covered marl was predominant. The beach along this section was mainly composed of material that had eroded from the cliffs. Plate 1.10 shows the typical beach composition, the cofferdam described in Section 1.1 and the partially completed permeable screen breakwater. In addition, the then site boundary for the barrage works is seen positioned along the northern flank of the final groyne (9).

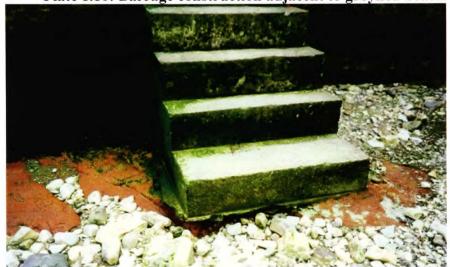
Plate 1.11: Steps northern flank groyne 8.

Average beach levels decreased progressively as the barrage site was approached. Consequently the sea frequently reached the base of the cliffs nearest the barrage site, evidenced by a lack of eroded deposits at the cliff base, coupled with increased cliff erosion. Plate 1.11 shows the steps on the northern face of the penultimate groyne (groyne 8). This clearly indicates undermining of the foundations, also apparent at other groyne locations. Once again, erosion was evident along this coastline. It is a reasonable assumption that, as neither Wallingford (1992) nor Bullen (1993a) indicated beach loss extent, there has been relatively recent changes in the nearshore zone.

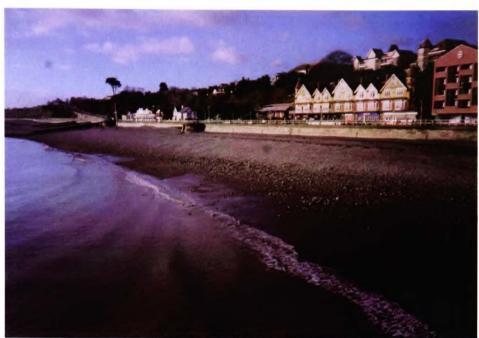
It is not unusual to find that a gently sloping shore platform occupies much of the near shore zone, and sometimes the lower part of the inter-tidal foreshore as well (Simm, 1996). These platforms adopt a much shallower slope than mobile sand or gravel under wave action, so that the underwater profile of the beach usually terminates at a more or less distinct line on the platform. In the case of Penarth, the shore platform is generally mud-covered marl and from Plate 2.1, the distinct termination of the limestone cobbles is clearly seen. Therefore, it is argued that for Penarth beach, this represents the depth of closure. Normally, the water depth at the depth of closure is in the range 4 to 6m but the actual water depth will be determined in Chapter 6.

Plate 2.1: Position of depth of closure, Penarth beach.

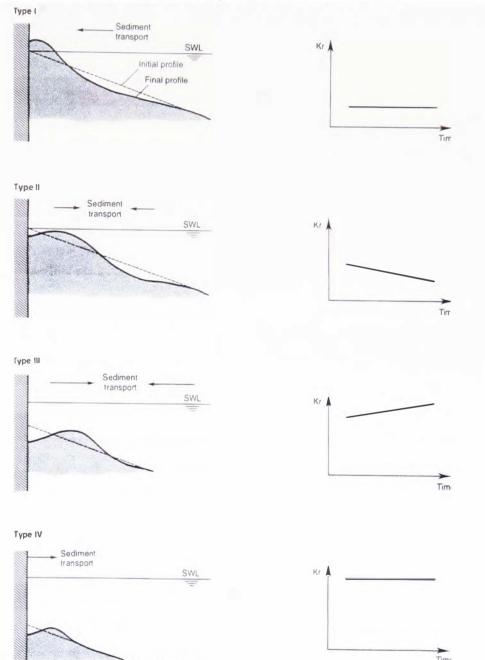
Figure 2.1: Scour/reflection behaviour (Source: Powell and Lowe, 1994)

model, shown in Figure 2.1, produces four different responses for wave/seawall interaction on coarse sediment beach profiles. These are as follows:

The toe depth increases with time and there is a general lowering of beach levels. As the beach level decreases, so the amount of reflected energy, and hence the proportion of onshore-to-offshore transport increases. Given sufficient time, beach levels can reduce to the Type IV condition.

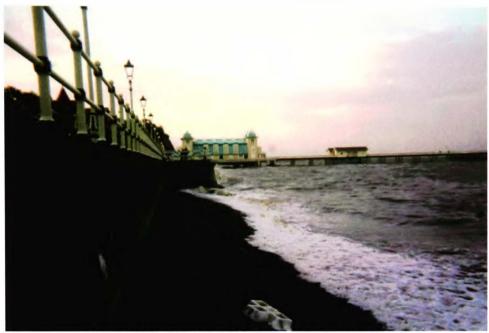
Plate 2.2: Wave reflection from Penarth seawall.

In the short term, wave reflection from seawalls (Plate 2.2) can affect the level of the fronting beach, and causes greater wave attack on the wall itself. The question of whether this leads to a continuing long-term lowering of beach levels is more complex, one not yet fully answered (Simm, 1996). In many situations, for example, beach levels seem to have almost stabilised in front of seawalls, and although the wave reflections are very strong, the beach has apparently adjusted to the new environment.

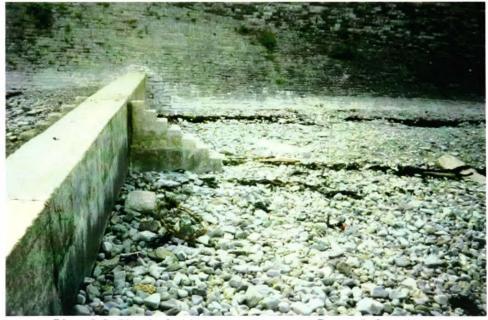
Plate 2.3: Vertical side concrete groyne, Penarth foreshore.

(Wallingford, 1990; SBCEG, 1999)) and beach composition would indicate that vertically sided concrete groynes (Plate 2.3) are appropriate at this location.

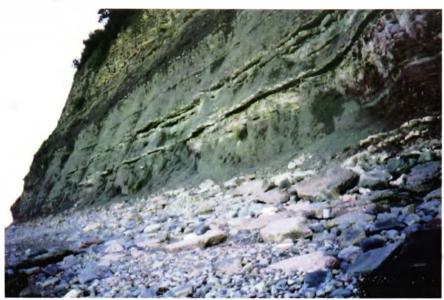
Plate 3.1: Cliffs at Penarth (September 1997)

The Rhaetic limestone and shale cliffs at Penarth (Plate 3.1) are constantly eroding (Bullen, 1993a) and recession rates of 0·2 m per year have been recorded (Williams and Davies, 1987; 1990).

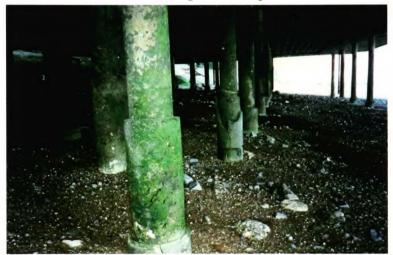
Plate 3.4: Columns to multi-storey car park (September 1997).

North of the pier there was a multi-storey car park that was demolished in autumn 2001 (Soltys: Brewster, 2003b) by the Coast Protection Authority (Vale of Glamorgan County Council; VGCC). It was originally closed in 1998, on the advice of structural engineers that it was unfit for public use and Plate 3.4, showed the condition of the supporting columns to the beach surface in September 1997. There is the remains of an old quay structure, which has now all but been destroyed by the sea (Plate 3.5), and the sea defences in the vicinity have suffered severe damage. The extreme northern end of the seawall had been repaired following collapse and much of the rest of the wall has been damaged (Plate 3.6). There is evidence of undermining and repairs are on going, a similar situation to that described by Wallingford (1992).

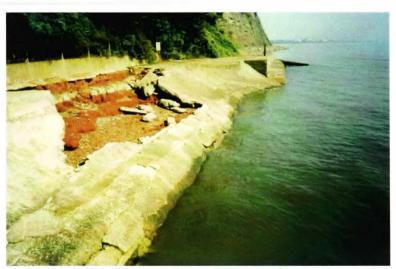
Plate 3.6: Damaged sea defences (September 1997).

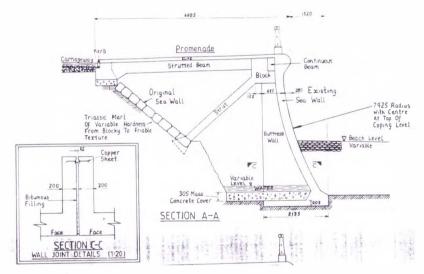
Figure 3.3: Section through Esplanade seawall. (Source: VGCC)

In 1924 the Penarth Urban District Council purchased the promenade and the pier from the Penarth Pier and Promenade Co. Ltd. (Ryan, 1983). The original seawall was constructed of stone pitching 200 to 300 mm in thickness at an angle of 40° to the horizontal (Figure 3.3). At the top of the wall, the junction with the promenade is made with a small concrete upstand. At the base of the wall, the original ground is horizontal before meeting the cutting slope of the seawall foundation.

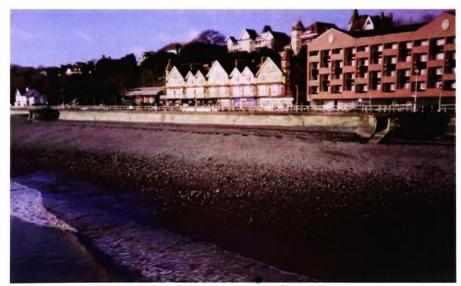
Plate 3.9: Esplanade Seawall

The main seawall was constructed during 1926/7 and is counterfort, supported at 3·6 m (average) centres by buttresses and struts. It carries the outer edge of the promenade slab with the inner edge supported at the top of the old seawall (Figure 3.3). The primary function of this wall is to protect the carriageway and seafront properties against the action of tidal and storm damage (Ryan, 1983; Bullen 1993a). The seawall is a constant 250 mm thickness, increasing to 535 mm at the wave return coping. It is concave when viewed from the beach (Plate 3.9), to a circular arc of approximately 7.9 m, the centre of which lies at the coping level. The toe at the base of the wall projects 1·3 m beyond the line of the coping face.

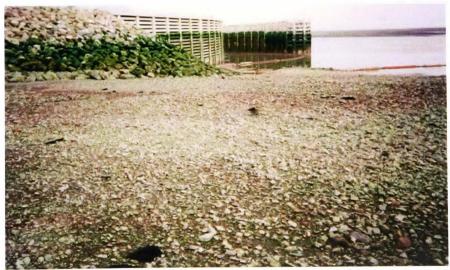
Plate 3.11: Barrage breakwater (April 1999).

Two breakwaters, each 20 m high and innovative in design, provide a sheltered harbour. The need to avoid excessive wave reflections, coupled with the very deep water at high tide, meant that conventional rubble embankments were inappropriate. The screen breakwaters consist of a permeable seaward screen formed with concrete "planks" with a solid screen on the harbour side (Plate 3.11). Waves hitting the breakwater are partly dissipated when passing through the front screen, and are then reflected from the solid screen. The reflected wave is then out of phase with the incoming wave which maximizes energy dissipation and minimizes the overall wave reflection from the structure. Optimisation of the dimensions of the screen breakwater was carried out in a physical hydraulic model (Hunter, 1996).

The breakwaters were constructed of float-in caissons, one of them being tied into the coastline with a traditional armoured embankment. The structures at Penarth Head and the eastern flank interfere directly with the natural low water channel of the Rivers Ely and Taff respectively. A new channel was designed to realign the flows, and Littlewood *et al* (1996) stated initial modeling highlighted problems of coping with mean annual fluvial flow. The design was modified to overcome this problem.

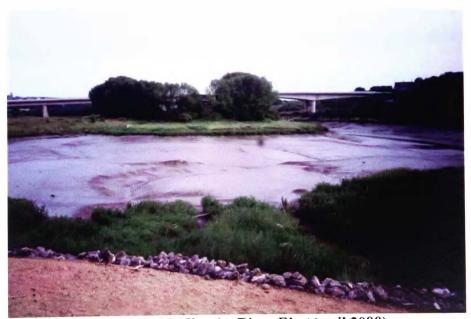
Plate 3.12: Mudbanks River Ely (April 2000).

Construction commenced in May, 1994 and the barrage was officially opened in November 1999, at an approximate cost of £200 million. On the 4th November, 1999, the sluice gates of the barrage were officially closed to prepare for the creation of the permanent freshwater lake. The changeover from an estuarine to freshwater environment means there will no longer be a brackish habitat. The lake was not initially freshwater because dredging operations in the impoundment had to be completed as a result of sediment oxygen demand. The mudflats, which are now submerged, were a Site of Special Scientific Interest (SSSI) as they provided winter feeding grounds for migrating wading birds, including Redshank and Dunlin. Cardiff Bay attracted high numbers of these birds because the elevation of the mudflats was higher than other areas, which meant they were exposed for longer during the tidal cycle. In addition, according to Hill et al (1996), the bay provided a sheltered stable environment. The mud banks upstream of the River Ely appear to have changed since the construction of the barrage. There is increasing sedimentation and mudbanks appear to have become more extensive (Plate 3.12). Although this is a qualitative observation, it would agree with that made by Dyrynda (1996), following the construction of the Tawe Barrage.

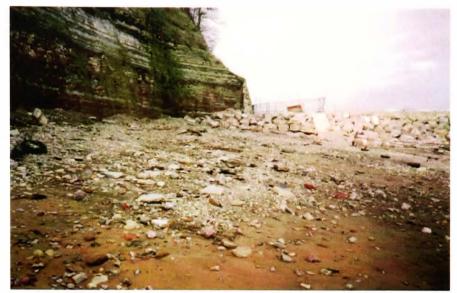
Plate 3.13: Accelerated cliff erosion (April 1999).

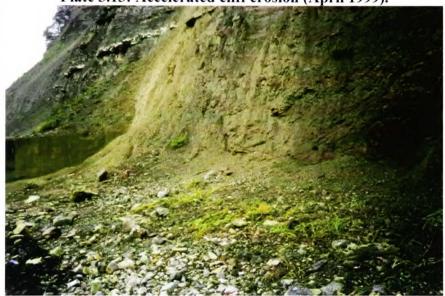
Plate 3.14: Mudslide adjacent to groyne 8 (September 1997).

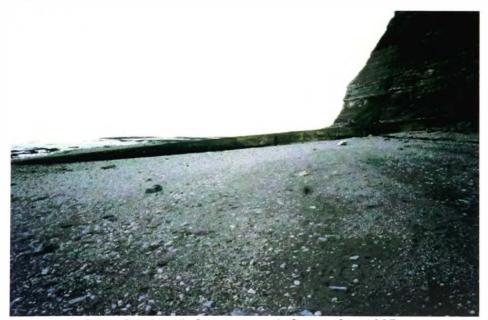
Plate 5.1: North face groyne 6 (September 1997).

Between station 26 and the mid point of the south face of groyne 6 (Figures 1.2 and 1.3), a 567m survey line was established to assess beach level change between the two orientations (NNE and NNW). This foreshore length is the least influenced by anthropogenic construction (Section 3.4) and the survey comprises three longshore ground positions: station 26 (750m), mid point (E) of manhole at orientation change (1245m) and mid point south face groyne 6 (1k; 1317m; Plate 5.1). These surveys would indicate differences in beach response to external change (natural or anthropogenic). A total of eight surveys were carried out between September 1997 and September 2002, coinciding with times of longshore profile and groyned beach surveys. Groyne 5 is located between the manhole and groyne 6. During the first surveys, this groyne, which is less substantial than groynes 6, 7, 8 and 9, did not demonstrate a level variation between north and south faces. It appeared that its construction had been linked to the sewer works (Plate 5.2) and consequently was not considered part of the groyned beach. Results are tabulated and evaluated in Chapter 6: Penarth beach.

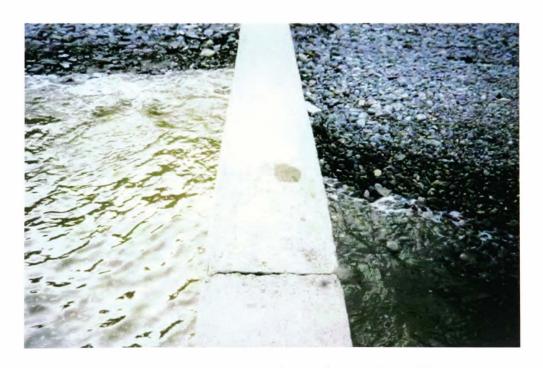
Plate 6.4: Groyne 1 at high tide, September 1997.

However, comparison with Plate 6.4 (September 1997), showed groyne 1 at high tide, and this clearly demonstrated beach levels south of the groyne were lower than to the north. Therefore, the position of the MHW had changed.

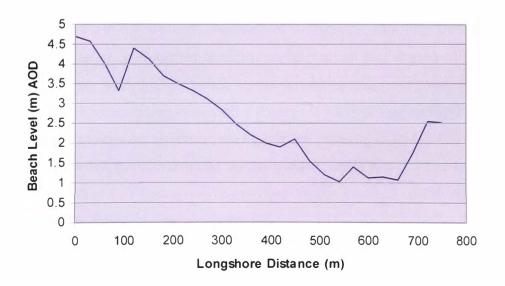
Figure 6.3: Longitudinal Profile, September 1997.

Figure 6.3, produced from Table 6.1, showed the September 1997 longshore profile. At distance 0 to 30m the profile showed rising southward beach levels, opposite to the OS line of the MHW between groynes 1 and 2, whilst Plate 6.5, the northern flank of groyne 1, illustrated a transition in the beach formation process. Section 1.2.1 highlighted erosional problems along this section with the exposed foundations of the southern flank of the Yacht Club slipway. Clearly the survey provided evidence of change along this section of the beach and suggested a reverse of the accepted south to north longshore drift.

The longshore profile for the next beach section (Figure 6.3), the old lifeboat slipway to Penarth Pier, stations 6 to 15 (longshore distance 150m to 420m), showed a northerly fall in level of 2.220m between the slipway and pier (Table 6.1). If the slipway was acting as a groyne, increased beach level at the slipway would again be consistent with a southern regime of sediment transport. Section 1.2.2 demonstrated a loss of beach material between 1992 and 1997 as well as a change in composition of beach material. The effects of this loss are highlighted in Plate 6.6 with the exposure of a Victorian cast iron storm water sewer. In addition, Wallingford (1992) reported that the pier acted as a partially effective groyne with higher beach levels to the south, consistent with the traditional south to north longshore drift. Figure 6.3 showed that although the pier still acted as a groyne, beach levels rose by 0.205m (stations 15 to 16; 420 to 450m longshore) between the southern and northern sides (Table 6.1). Once again this length of coastline had undergone change and similar to south of the slipway, a north to south sediment regime was indicated.

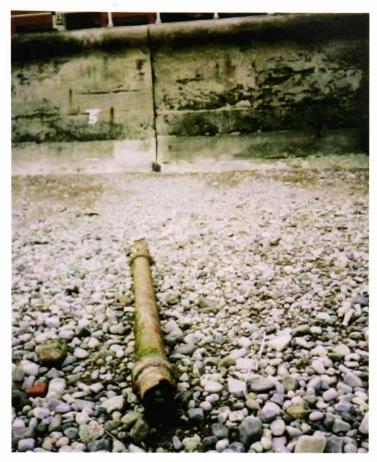
Plate 6.6: Exposed Victorian cast iron sewer

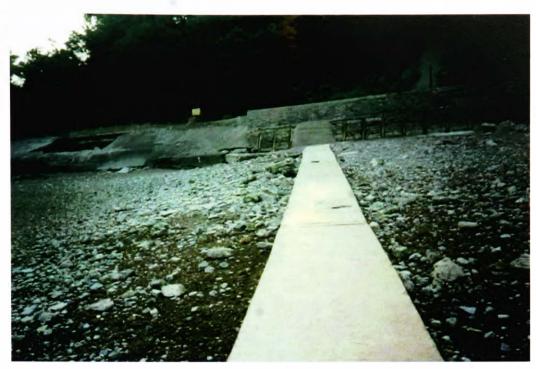
In July, 1997, the contract to construct a new 1 m diameter sea outfall was completed. This outfall, inside a concrete culvert, replaced twin 600 mm diameter cast iron pipes. The new outfall, had higher beach levels on the northern flank and, at one location, the level difference was 750 mm. According to the Resident Engineer responsible for the contract, on completion, beach levels were left approximately the same on both sides of the outfall (Bright, 1997: pers. comm.).

Plate 6.7: Concrete culvert for 1m diameter sea outfall.

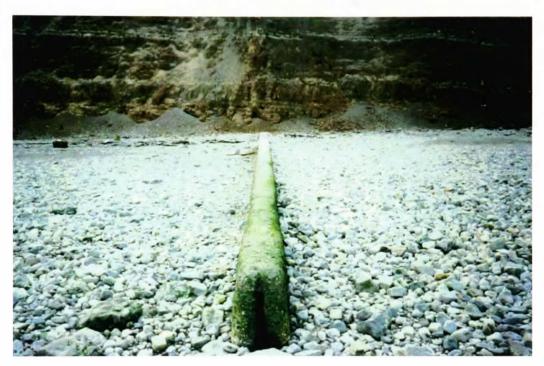
Plate 6.9: Groyne 4, September 1997.

Examination of groyne 4 (Plate 6.9) showed higher beach levels on the northern flank and similar to groyne 1, there was a change in position of the MHW. Once again both Bullen (1993a) and Wallingford (1992) agreed that this section of the coastline was subject to a net northward drift of beach material with frequent

references made to retention of material on southern flanks of structures. Wallingford (1992) and Bullen (1993a) both further highlighted damage suffered by coastal defences along this section. There was no doubt that increased loss of beach material was further undermining sea defences and evidence justified perceptions of change. Similar to the rest of the beach, a southward drift of beach material had been shown.

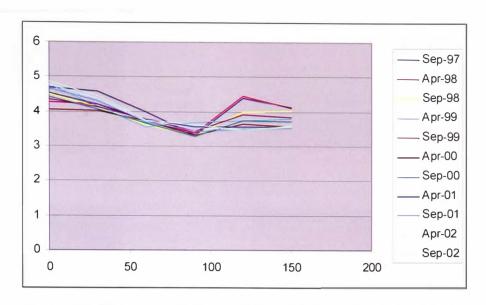
Figure 6.5: Temporal variation of longshore profile stations 1 to 6.

This section of the beach, is shown in Figure 6.1 and Plate 6.1 and included stations 1 to 6 (0 to 150m longshore). Figure 6.5, produced from Table 6.1, further detailed the beach profiles for the eleven surveys where it was clearly seen that the beach level at station 2 (30m), between groynes 1 and 2 (Plate 6.10), was at its highest in September 1997. At that time beach levels were similarly high at station 5 (120m), between the old and new lifeboat slipways but conversely, near their lowest at station 4 (90m), the location of the exposed foundations of the Yacht Club slipway, (Section 1.2.1). However, Figure 6.5, although useful for an overview of changing profiles, did not facilitate identification of trends. Consequently, as the first survey provided the baseline data, Figure 6.6 compared each successive longshore profile with the September 1997 position.

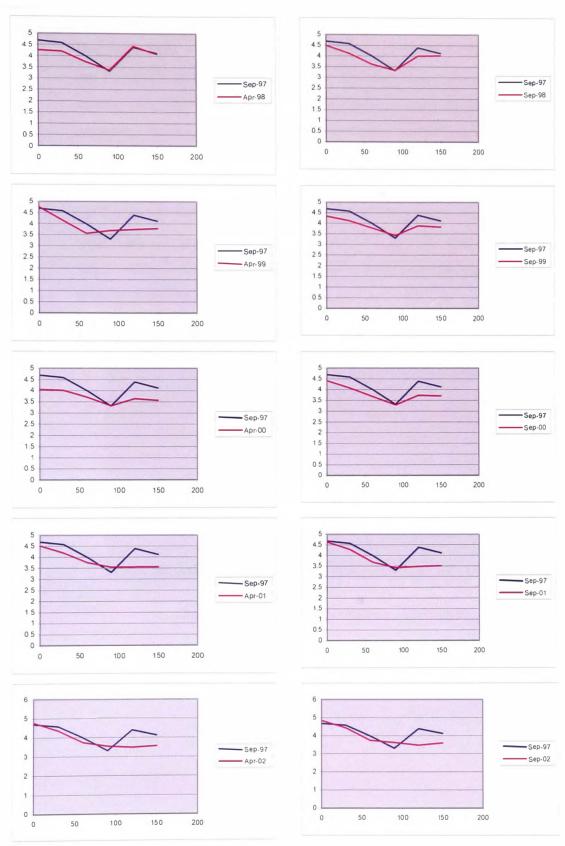
Figure 6.6: Temporal comparison of profiles (varying timescales) with September 1997 (0 to 150m).

Between September 1997 and April 1998, beach levels fell between stations 1 and 4 (0 to 90m) whilst remaining relatively constant to station 6 (150m), with a consequent average loss of 0·197m (Table 6.1). By September 1998, overall beach levels along the section had fallen still further to an average 0·284m below September 1997 but more significantly, had decreased between stations 4 and 6 (90m to 150m). In April 1999, mean beach levels had risen to 0·208m below September 1997 and the level peak and trough between stations 3 and 6 (60 to 150m) was replaced by a more uniform profile. Between stations 1 and 3 (0 to 60m) groynes 1 and 2 influenced longshore transport but the rising south to north gradient between stations 3

and 6 (60 to 150m) may have indicated a return to a south to north longshore drift. The effects of increased beach levels at station 4 (90m) can be clearly seen in Plate 6.11 where the foundations of the Yacht Club slipway were no longer visible. The return to a south to north sediment transport system was further supported by beach levels being clearly higher on the southern flanks of groynes 1 and 2 respectively (Plates 6.12 and 6.13) and Plate 6.14 the old lifeboat slipway looking northwards towards the Esplanade. Plate 6.15 of the northern flank of groyne 1, when compared with Plate 6.5, highlighted definite beach loss and this was such that the steps on the northern flank of the groyne were suspended approximately 0.150m above the beach surface (Plate 6.16).

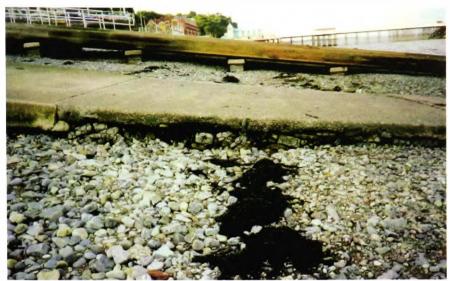
Plate 6.18: Exposed slipway foundations, September 1999.

However, by September 1999, average beach levels along this section had once again fallen to 0.278m below September 1997. Most significantly, the loss of beach material at station 4 (90m) led to the re-exposure of the foundation of the Yacht Club slipway (Plates 6.17 and 6.18). At this time the barrage breakwater had been completed and work had started on the final closure of the Cardiff Bay Barrage. By April 2000, average beach levels along this section had fallen to their lowest point during the monitoring period, 0.449m below September 1997 (Table 6.1). September 2000 saw average beach levels increase to 0.359m below September 1997 and this was the start of a consistent rise in average beach level: 0.271m (April 2001), 0·277m (September 2001), 0·222m (April 2002) and 0·176m (September 2002) below September 1997 levels. However, it was not until April 2001 that the foundations to the Yacht Club slipway were once again covered. Further examination showed that from April 2001, there was less profile variation. It appeared that beach processes had become more uniform and by September 2002, as measured over the five-year period, the beach level at station 1 was at its highest, whilst the level at station 6 (150m) was almost at its lowest value, (Table 6.1). Plates 6.19 and 6.20 show that beach levels were once again higher on the southern flanks of groynes 1 and 2 respectively whilst Plate 6.21 showed the marl bedrock exposure on the northern flank of groyne 2. The Yacht Club slipway foundations were no longer exposed (Plates 6.22 and 6.23) and Plate 6.24

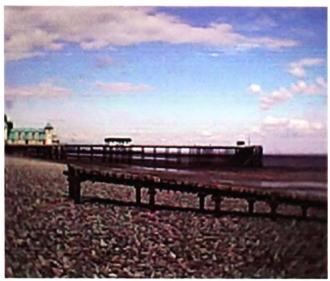
Plate 6.24: Old lifeboat slipway, September 2002.

demonstrated the effects of the overall reduction in level at stations 5 and 6 (120m and 150m longshore). This resulted in a more uniform gradient across the old lifeboat slipway which, by then, had partially collapsed. Furthermore, over the five years, the beach level at station 5 (120m) varied the most compared with any other station over the whole 750m baseline, that is, 0.925m with the next largest variation 0.535m at station 23 (660m: Table 6.1). Therefore, by September 2002, beach profiles and photographic evidence were more consistent with a return to the traditional south to north sediment transport rather than the north to south movement shown in the earlier surveys.

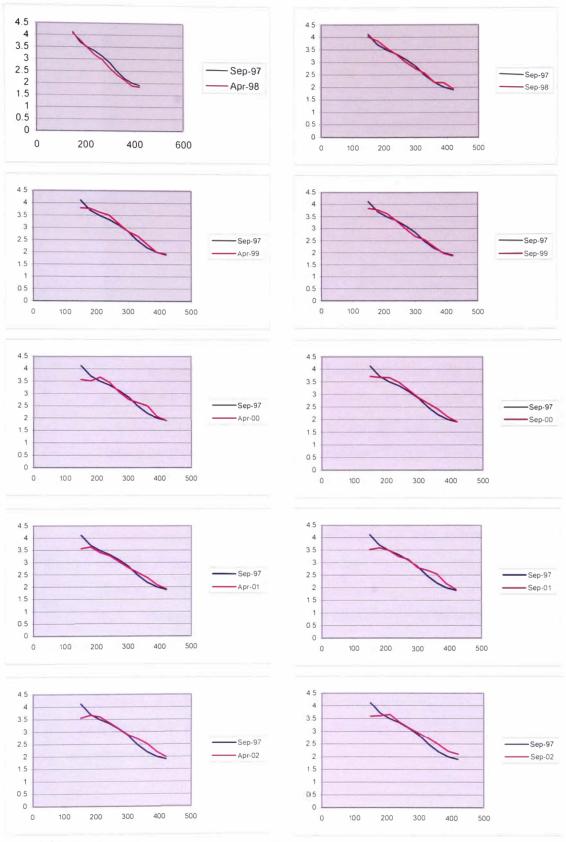
Figure 6.11: Temporal comparison of profiles (varying timescales) with September 1997 (150 to 420m)

Between September 1997 and April 1998, with the exception of station 7 (180m), beach levels fell along this part of the foreshore by an average of 0·090m (Table 6.1). This coincided with the lowest recorded mean beach level during the five-year investigation (2·832m). Plate 6.25, at that time, showed the further exposure of the cast iron storm water sewer seen in Plate 6.6 and the Penarth Times (1998) highlighted concerns, reporting that Councillors believed that dredging may be to blame. However, by September 1998, overall beach levels along this section had *risen* to an average 0·018m above September 1997 (Table 6.1).

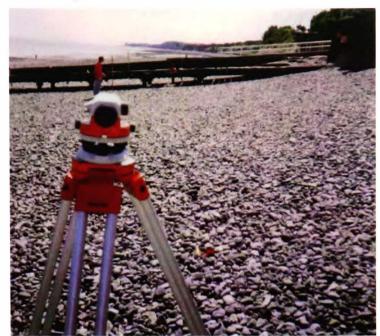
Plate 6.26: Station 6, old lifeboat slipway, September 1998.

In April 1999 mean beach levels had risen still further to 0·042m above September 1997 but significantly beach levels had fallen by 0·330m at station 6 (150m). The effects of this fall were seen when comparing Plate 6.26 (September 1998) with Plate 6.27 (April 1999). Conversely, at the northern end of this section, beach levels had risen and once again, comparison of Plates 6.28 (September 1997) and 6.29 (April 1999) showed increased nourishment on the part of the beach that had caused the initial erosion concerns. Similar to what had occurred south of the lifeboat slipway, there was an indication of a return to a south to north longshore drift. This situation highlighted the problems faced by beach managers and decision-makers in avoiding hasty decisions when developing strategies to manage the coastal zone. Although anthropogenic activities previously blamed for erosion of the beach were ongoing, that is, the barrage construction and marine aggregate dredging, the beach indicated signs of recovery.

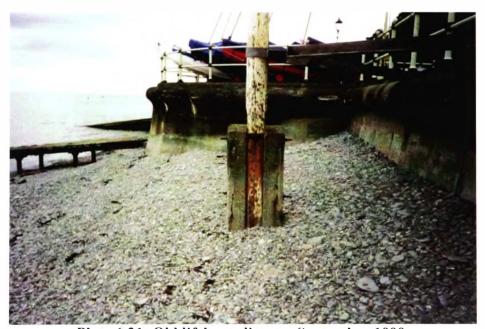
Plate 6.31: Old lifeboat slipway, September 1999.

However, by September 1999, average beach levels had once again fallen to 0.037m below September 1997 (Table 6.1). Comparison of photographs of the beach adjacent to the old lifeboat slipway clearly showed increased beach levels at this location. Plates 6.30 (April 1999) and 6.31 (September 1999) showed the beach adjacent to the old lifeboat slipway and clearly demonstrated increased beach levels at this location. Note particularly the base of the mast adjacent to the seawall. This change was similar to that

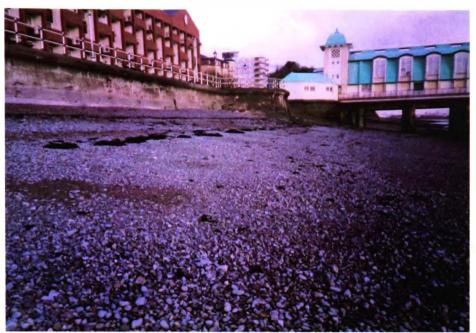
Plate 6.34: Foreshore north, September 2001.

adjacent to station 10 (270m), Plate 6.34 looking northwards towards the pier, and Plate 6.35 at the steps adjacent to station 14 (390m). These provided stark contrast to the beach condition in September 1997 (Plate 6.28).

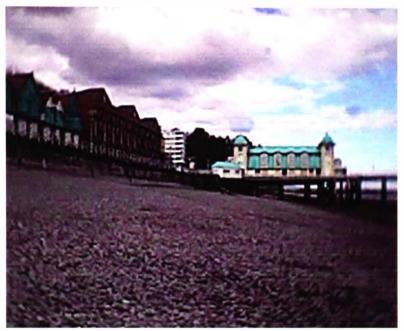
Plate 6.36: Penarth foreshore, September 2002.

The final survey in September 2002 saw the mean beach level increase to the highest recorded during the five-year monitoring period; 0.058m above September 1997 (Table 6.1). Interestingly, comparison of Plate 6.36 with Plate 1.2 (Bullen, 1993a) indicated that the beach was recovering, conditions being more like September 1992 rather than September 1997. Further examination of Figure 6.11 indicated that between September 1997 and September 2002, beach levels had increased over the northern half of this section, which further supported a return to the traditional south to north longshore sediment movement.

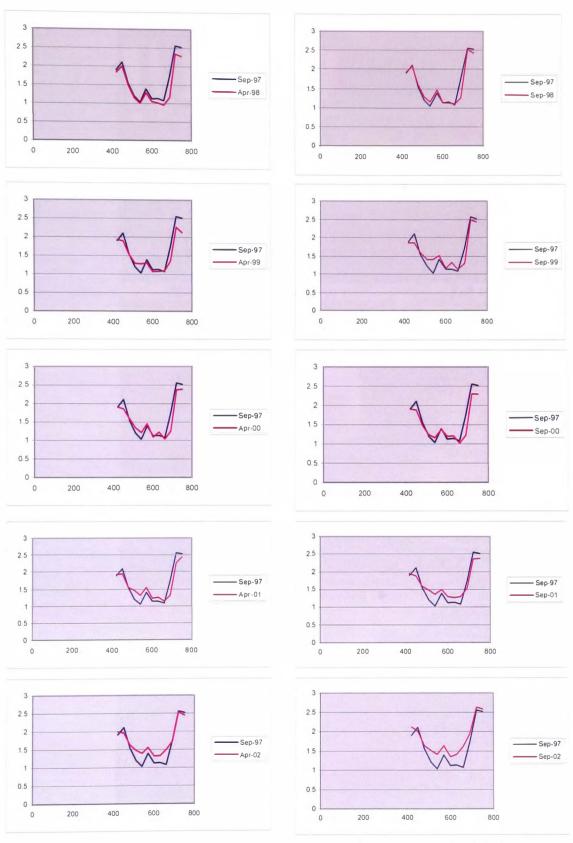
Figure 6.16: Temporal comparison of profiles (varying timescales) with September 1997 (420 to 750m)

Without exception, between September 1997 and April 1998, beach levels fell along the whole of this section of the coastline by an average of 0·156m to 1·431m (Table 6.1), the lowest recorded during the five-year investigation. Immediately north of the pier, Plate 6.37 indicated effects of beach loss with the exposure of the 0·300m diameter surface water outfall. Similar to the other storm water sewers, these Victorian pipelines were originally constructed to discharge below the surface of the beach. Plate 6.38 looked northwards from station 15 (420m) and detailed lack of pebble covering beneath the pier, whilst Plate 6.39 shows the multi-storey car park and damaged sea defences, exposed marl bedrock and the concrete sewer culvert constructed the previous year.

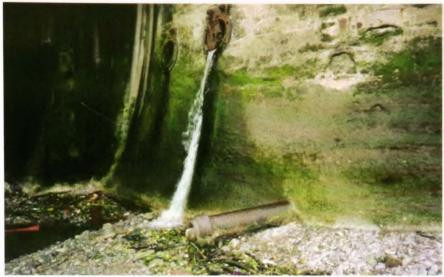
Plate 6.40: Exposed sewer north of Pier, September 1999.

Plate 6.42 (April 2002) showed increased beach levels near the storm sewer, shown in Plate 6.40, whilst Plates 6.43, 6.44 and 6.45 showed the beach following the demolition of the multi-storey car park at the end of 2001. Significantly, there was little indication of the exposed marl bedrock which had been predominant in September 1997. In September 2002, beach levels had further recovered, as evidenced beneath the pier by a comparison of Plates 6.46 and 6.38 and Plate 6.47 of the surface water sewer compared with Plate 6.40. Plate 6.48 of the sewer outfall and Plate 6.49 of groyne 4 compared with Plate 6.9, showed higher beach levels on southern flanks.

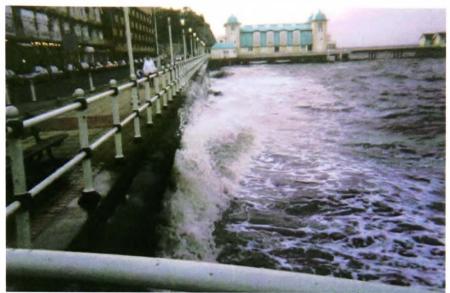
Plate 6.52: Easterly storm stations 10 to 14, 18th May 1999.

The 18th May, 1999, was the second day of easterly storms where, at high tide, wave energy caused flooding along the Esplanade. Plate 6.52 showed the section of seawall backing stations 10 to 14 (270 to 390m longshore), whilst Plate 6.53 showed the easterly driven waves between stations 6 and 10 (150m to 270m longshore). Sediment motion was observed with pebble sizes greater than 150m diameter, being freely displaced in a southerly direction. Consequently, the survey in September, 1999 produced some interesting results. From Table 6.14, it was seen that the overall beach grid levels had fallen by 0.159m, equivalent to a loss of 1,148·4m³ (2,526 tonnes) of beach material. This loss comprised 133·2m³ between stations 6 and 10 and 1,015·2m³ between stations 10 and 14. The average longshore gradient had once again steepened to 0.664% (Table 6.16) whilst since April 1999 the cross-shore gradient at station 6 (150m) had increased by 0.6% to 11.8% and at station 14 (390m) had decreased by 2.1% to 9.2% (Table 6.17). These results supported the predictions of Wallingford (1992), discussed in Section 2.2.3, that the largest waves at Penarth occur at high water, arrive from 50 to 90 degrees true and produce an element of southward drift.

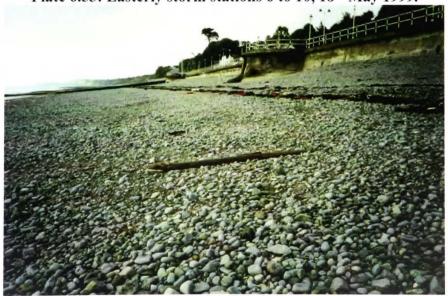
Plate 6.54: Exposed Victorian sewer near station 12, September 1999.

Plates 6.54 and 6.55 once again showed the consequences of the loss of beach covering with the re-exposure of the Victorian cast iron surface water sewers. These conditions were similar to those of September 1997 (Plate 6.6) and April 1998 (Plate 6.25), whilst the base of the steps, shown in Plate 6.29, further illustrated the change from April 1999. Plate 6.56 showed the tide line along the foreshore and indicated the rising plane of the beach in a southerly direction. Therefore it is concluded that the total loss of beach material from this part of the beach face was in a southerly direction, that is, a north to south sediment transport.

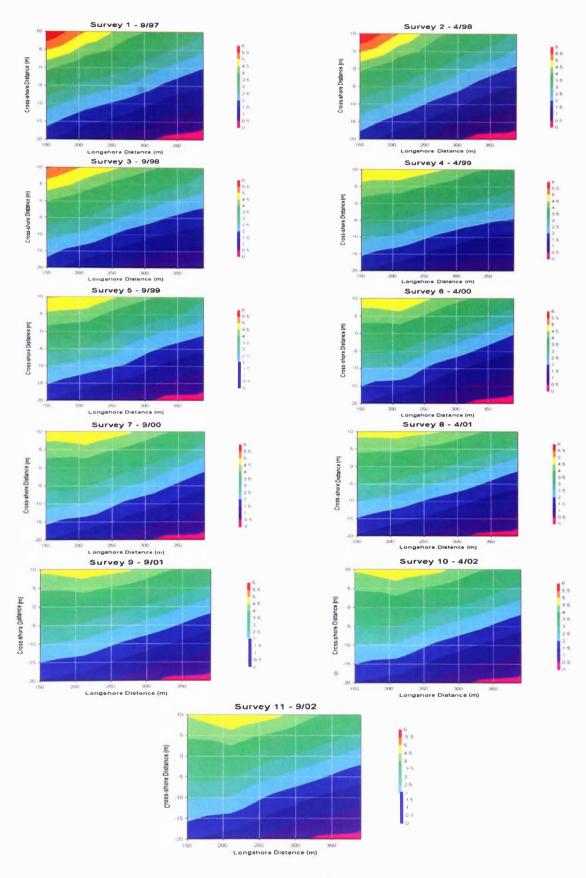
Figure 6.30: Foreshore Grid - Chronological change of beach contours

Tables 6.3 to 6.13 inclusive were imported into a Dplot package to produce two and three-dimensional survey representations of the foreshore grid area of the beach. The two-dimensional plots (Figure 6.30) demonstrated the chronological change in spatial-distribution of beach material between September 1997 and September 2002. It must be remembered that there is a scaling factor of ³⁹⁰/₃₀:1 or 13:1 longshore to cross-shore, that is, 1m cross-shore is equivalent to 13m longshore. Therefore, changes in cross-shore position are exaggerated from natural scale plan position, but this magnification enabled change to be more easily identified. The consequences of material movement along the foreshore were subsequently evaluated from these plots.

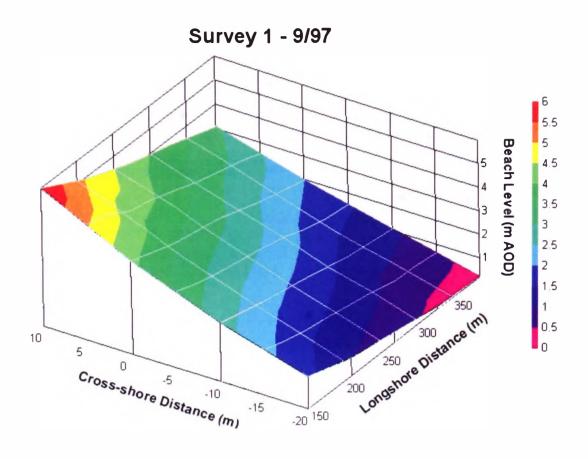
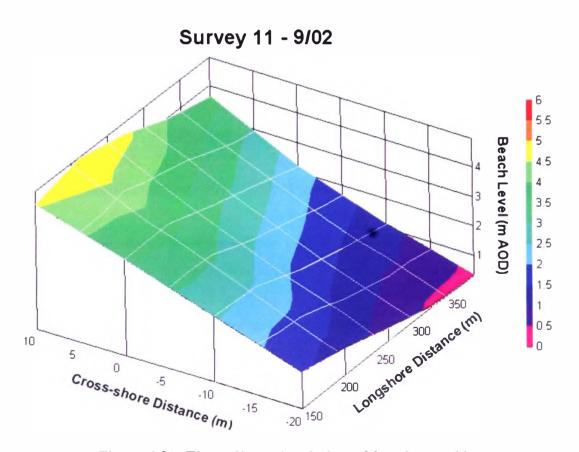
Figure 6.31: Three-dimensional plots of foreshore grid

To further demonstrate changes that had occurred between the first and last surveys, three-dimensional views were prepared, and shown in Figure 6.31. Comparison of these plots illustrated the changes in longshore and cross-shore gradients, discussed in Section 6.3.6. The reduced steepness of longshore gradients between September 1997 and 2002 was clearly illustrated, whilst there was verification of reduction in cross-shore gradient at station 6 (150m longshore) and increase at station 14 (390m longshore). The back beach profile in September 2002, shown in Figure 6.31, identified a build-up of material between 150m and 250m longshore, and reflected beach conditions shown in Plate 6.57. This provided evidence that the survey results and extrapolation appropriately represented beach conditions.

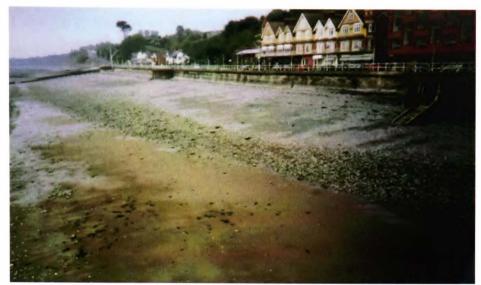
Plate 6.58: Esplanade foreshore, September 1998.

Plate 6.58 showed the foreshore in September 1998 and the plan position of the depth of closure, the cross-shore boundary of the pebble beach, was clearly seen. Distances from the longitudinal profile were 55m cross-shore at station 6 and 20m cross-shore at station 14 (Table 6.20). Plate 6.59 showed the foreshore in September 2000, the mid-point of this particular survey period when the cross-shore distances to the boundary of the pebble beach were 45m at station 6 and 30m at station 14 (Table 6.20). Finally, Plate 6.60 from September 2002, showed the effects of increased beach levels at station 14, with the more uniform strandline across the length of the foreshore.

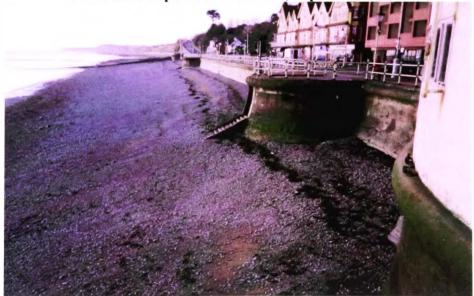
Plate 6.60: Esplanade foreshore, September 2002.

At that time, the line of the seaward edge of the pebble beach from the longshore profile was 29m cross-shore at station 6 (150m) and 50m cross-shore at station 14 (390m). These results were consistent with a change in longshore drift from a southerly to northerly direction. Therefore, these results further validated the conclusions made in Sections 6.2 and 6.3.

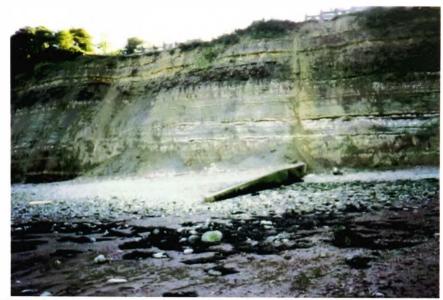
Plate 7.2: Groyne 8, bays 2 and 3 (September, 1997 see Figure 7.2).

Plate 7.2 showed groyne 8 and bays 2 and 3, where from Table 7.1, it can be seen that the average level in bay 2 was 0·347m higher. The implications of this level difference meant that eroded cliff material remained at the cliff toe in bay 2. The difference in beach material distribution between the bays is clear, as seaward of the groyne limits, mud covered marl was predominant and the groynes successfully retained beach material. The proximity of houses at the cliff top (approximately 15m) may result in future problems when considered in conjunction with Plate 7.3.

This survey was undertaken on completion of the breakwater construction and subsequent available access to the beach. Groyne 9 (Figure 7.2) was no longer in existence having been incorporated into the breakwater construction. Consequently, the width of bay 3 reduced from 57m to 43m, a loss of 14m. From Table 7.11 there was an average increase of beach level of 0·137m which corresponded to an overall increase in volume of 833m³ (>1,830 tonnes; Table 7.12). This was clearly shown in Plate 7.7 where the beach had extended beyond the extremity of groyne 8 and provided a stark contrast to conditions shown in Plate 7.2. This was

These increases allowed further accumulation of material at the cliff toe (Plates 7.12 and 7.13) whilst the strandline was located a minimum 5m from the cliff face. Plate 7.14 showed bay 3, groyne 8 and the rock spit joining the breakwater to the cliffs. A comparison with Plate 7.7 showed once again that the material composition clear of the groyne field had changed, similar to conditions in Plate 7.2, despite there being an overall increase in beach level.

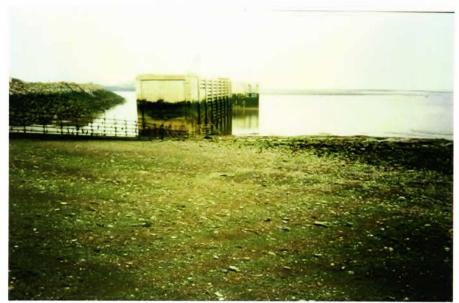
Plate 7.4 showed the bottom of bay 3, its relation to the Barrage cofferdam construction, the breakwater caissons and groyne 9, which was

the site boundary of the Cardiff Bay Barrage. The beach at the top was mainly weathered red and green marl from the cliff face whilst larger limestone pebbles were retained towards the southeast of the bay. Table 7.13 indicated that there was a reduction in longshore gradients across the centre line of the three bays, that is, 2.8% (Bay 1), 1.1% (Bay 2) and 0.5% (Bay 3), whilst Table 7.14 showed a similar reduction in mean cross-shore gradients, that is, 12.8% (Bay 1), 12.3% (Bay 2) and 11.6% (Bay 3). Again this was consistent with lower beach levels adjacent to the barrage.

Plate 7.4: Barrage breakwater construction (September 1997).

Similarly, when Plate 7.9 was compared with Plate 1.11, the increased beach levels provided protection to the steps on the northern face of groyne 8. The barrage construction was approaching completion and Plate 7.10 showed the varying level of the beach adjacent to the completed breakwater. Comparisons with Plate 7.4 once again illustrated the changes that occurred between Surveys 1 and 3.

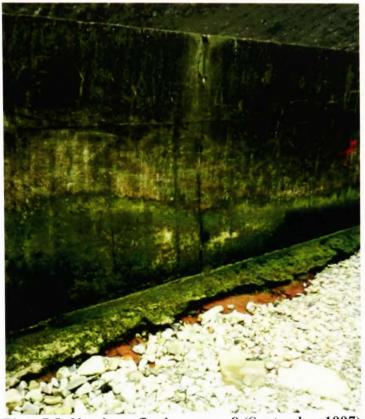
Evidence of change from conditions reported by Wallingford (1992) and Bullen (1993a) are illustrated in Plate 7.5. The northern face of groyne 8 was clearly being undermined, as were other locations along the groyne (Plate 1.11). This incidentally indicates the uncertainty as to the depth of the marl bedrock below the beach surface as the exposure of the marl under the steps is at least 3m higher than that exposed immediately seaward of the groynes. Plate 7.6 shows the southern side of groyne 8 and would indicate a loss of beach covering. Unfortunately no past profiles along this coastline stretch were available for comparison purposes. Consequently another factor for consideration would be the location of the cofferdam and caissons which might have caused a localised change in tidal and current patterns which contributed to the loss of beach material. This would help to explain

the longshore and cross-shore changes approaching the barrage, that is, a consistent reduction of 60% (longshore) and 0.3° (cross-shore).

Plate 7.5: Northern flank, groyne 8 (September 1997).

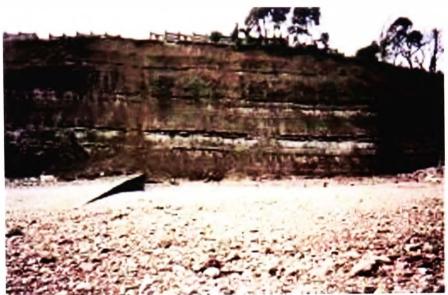
Plate 7.7: Groyne 8, bays 2 and 3 (February, 1999).

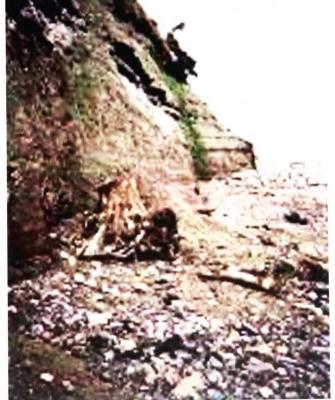
further evidenced by the average increase of beach level at the groyne limits of bay 3 of 0.252m (Tables 7.2 and 7.3). Plate 7.8 shows the location where the breakwater joins the cliff face. Comparisons with Plate 7.3 indicated that the effects of increased beach levels in bay 3 meant weathered material remained at the cliff toe.

Plate 7.8: Beach/cliff interface, bay 3 (February, 1999).

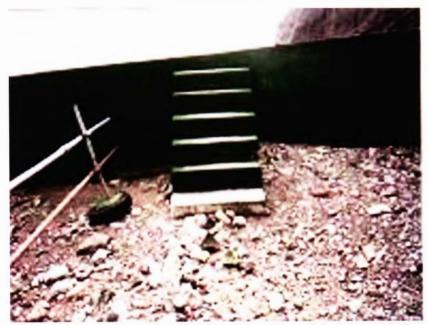
Plate 7.9: Steps northern flank, groyne 8 (February 1999).

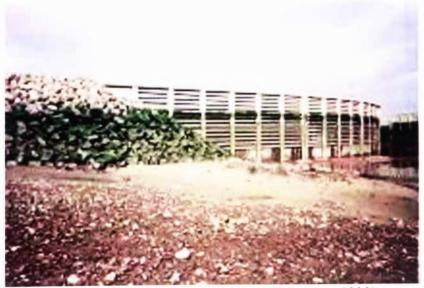
Plate 7.10: Barrage breakwater (February 1999).

For completeness, the following photographs provide a record of the groyned beach on completion of the monitoring survey in September 2002. The stepped access across the rock spit onto the beach (bay 3), shown in Plate 7.15, suffered damage in just three years (Plate 7.16). This provided a timely reminder of the hostile environment and the power of the natural forces at work. Plates 7.17, 7.18 and 7.19 shows the breakwater from different positions along bay 3 and indicate variation in beach composition. The cross-shore gradient of 11.5% (Table 7.14), equivalent to a beach angle of 6.6° , could be seen and comparison of Plates 7.10 and 7.18 showed beach changes where the rock spit joined the caissoned breakwater.

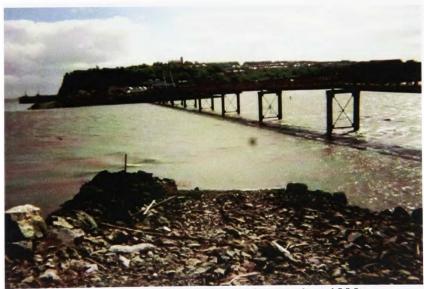
During the inter-survey period, work had started on the final closure of the barrage (Plate 7.11), which would ultimately lead to tidal exclusion and form the freshwater lake.

Plate 7.11: Barrage closure (September 1999).

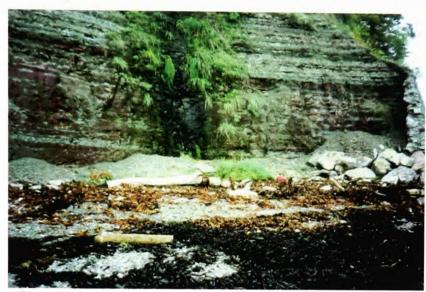
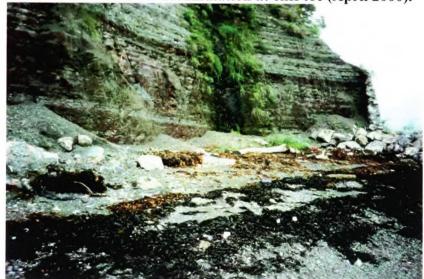
Plate 7.12: Sediment accumulation at cliff toe (April 2000).

Plate 7.13: Strandline and beach/cliff interface bay 3 (April 2000)

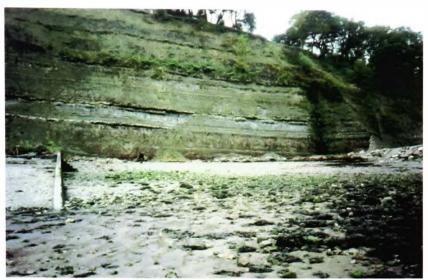
Plate 7.14: Groyne 8, bays 2 and 3 (April, 2000).

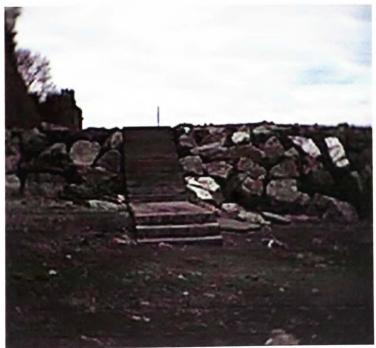
Plate 7.15: Stepped access - main breakwater (September 2002).

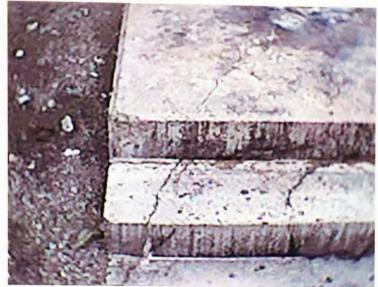
Plate 7.16: Tidal damage to steps (September 2002).

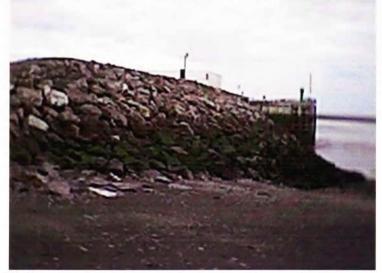
Plate 7.17: Beach composition end of rock spit, bay 3 (September 2002).

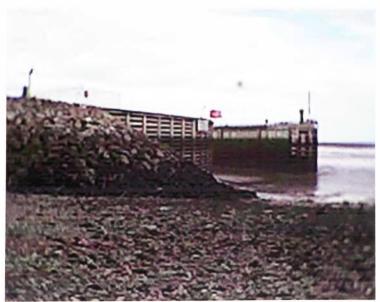
Plate 7.18: Variation in beach covering, bay 3 (September 2002).

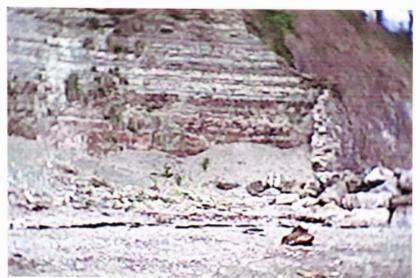
Tidal processes had removed the sandy construction material that remained following cofferdam removal and rock spit completion. Plate 7.20 once again shows the accumulation of material at the cliff toe which reinforced the effects of increased beach levels when comparison was made with Plate 7.3 (September 1997). Plate 7.2 showed accumulations of material at the toe of the cliffs in bay 2, which, in September 1997 had a mean back beach, level of 6·467m (Table 7.1). The mean back beach level in bay 3 in September 2002 was 6·590m (Table 7.10) from which it can be concluded that the level increases in bay 3, also highlighted in Surveys 3 and 5, meant that tidal action no longer reaches the toe of the cliffs. This was further evidenced by Plate 7.21, which showed the corner of bay 3 adjacent to groyne 8. This was the lowest part of the back beach where there was a reduction in material at the toe of the cliffs.

Plate 7.20: Accumulations back beach, bay 3 (September 2002).

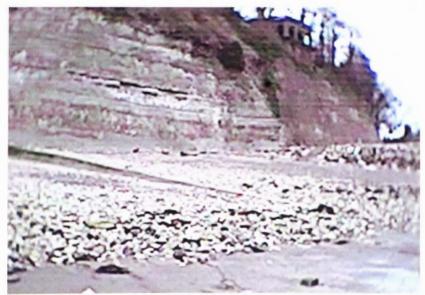
Plate 7.22: North view - groyne 8, bays 2 and 3 (September 2002).

Plate 7.22 showed groyne 8 and bay 3. If a line was drawn diagonally from the top of groyne 8 to the bottom of the rock spit, fine material was to the north and larger pebbles to the south. This was the same as Phillips (1999b) reported following the first survey in September 1997. Plate 7.23 showed the bottom of groyne 8 looking southwards across bay 2.

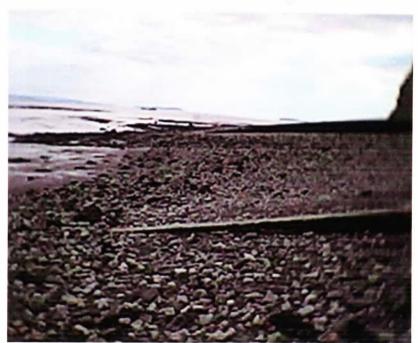
Plate 7.23: South view - groyne 8, bays 2 and 3 (September 2002).

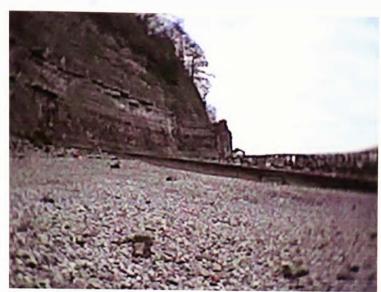
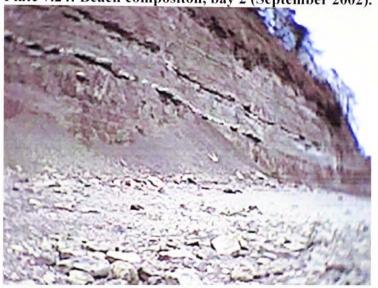
Plates 7.24 and 7.25 show typical material distribution and accumulation of weathered material at the cliff toe in bay 2. The top of groyne 7 in Plate 7.26 had not been attached to the cliffs where the irregular marl face meant that there was a gap of approximately 0.6m. The mean level of this bay had fallen by 0.068m over the monitoring period (Table 7.11) whilst the mean level of the back beach had risen by an average of 0.128m (Tables 7.1 and 7.10). Observations made in bay 1 are illustrated in Plates 7.27 and 7.28. Accumulations of material were seen once more at the toe of the cliffs. The mean beach level had fallen by 0.016m since September 1997 (Table 7.11) although, as in the case of bay 2, the mean level of the back of the beach had risen by an average of 0.190m (Tables 7.1 and 7.10).

Plate 7.24: Beach compositon, bay 2 (September 2002).

Plate 7.25: Accumulations at cliff toe, bay 2 (September 2002).

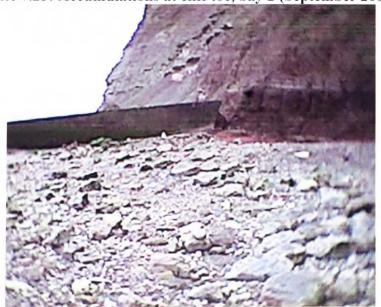
Plate 7.26: Interface of cliff and groyne 7 (September 2002).

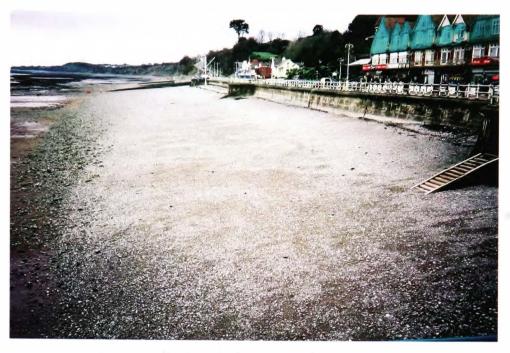
The formula is the end result of a huge amount of quantitative fieldwork (Chapters 6 and 8). It was shown that this model accurately reflected changing processes along the beach and is a simple formula for a manager to assess beach movement. The collection of quantitative data is often expensive and time consuming but there is a need for long-term quantitative data related to beach dynamics (Galofre and Montoya, 1995). Effectively this formula reflects quantitative assessment but will not be time consuming or expensive to implement. With reference to Plate 9.3, for a guide, this would involve measuring the cross-shore distances, x, from station 14 (approximately 1m south of the steps) and station 6 (adjacent to the old lifeboat slipway) to the seaward boundary of the pebble beach.

Plate 9.3: Esplanade foreshore - December 2004.

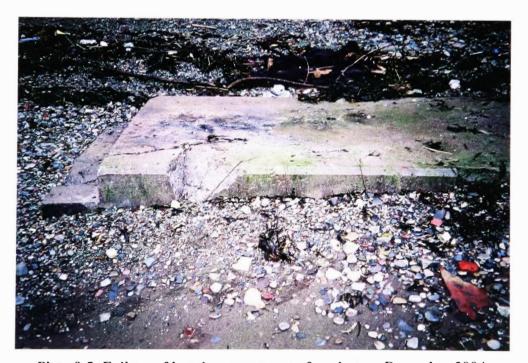
Plate 9.5: Failure of breakwater steps to foreshore, - December 2004.
